155-mm Howitzer Malfunction Investigation: A Laboratory Study of the Igniter Train Operation

ARL-TR-2106

November 1999

Army Research Laboratory

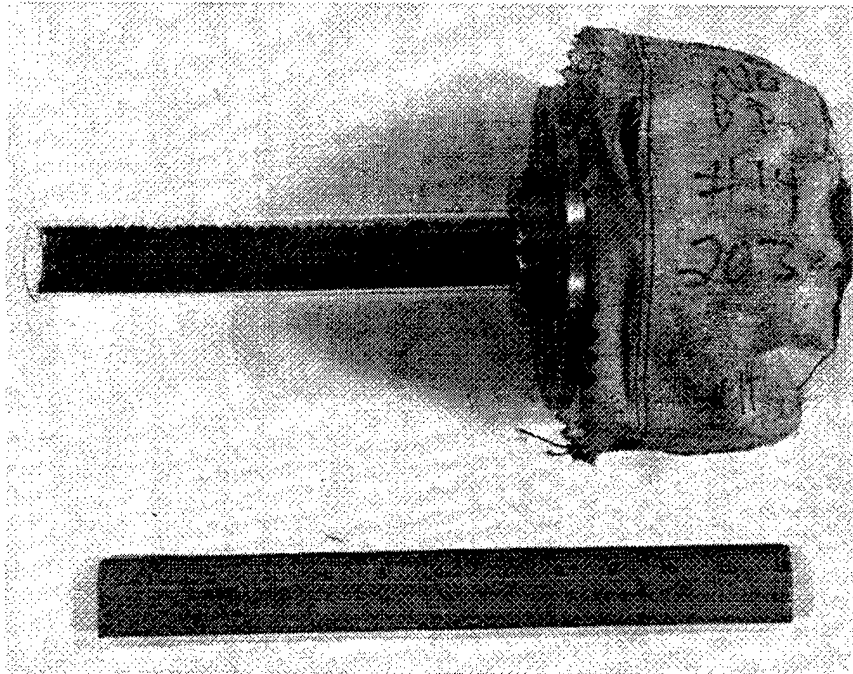
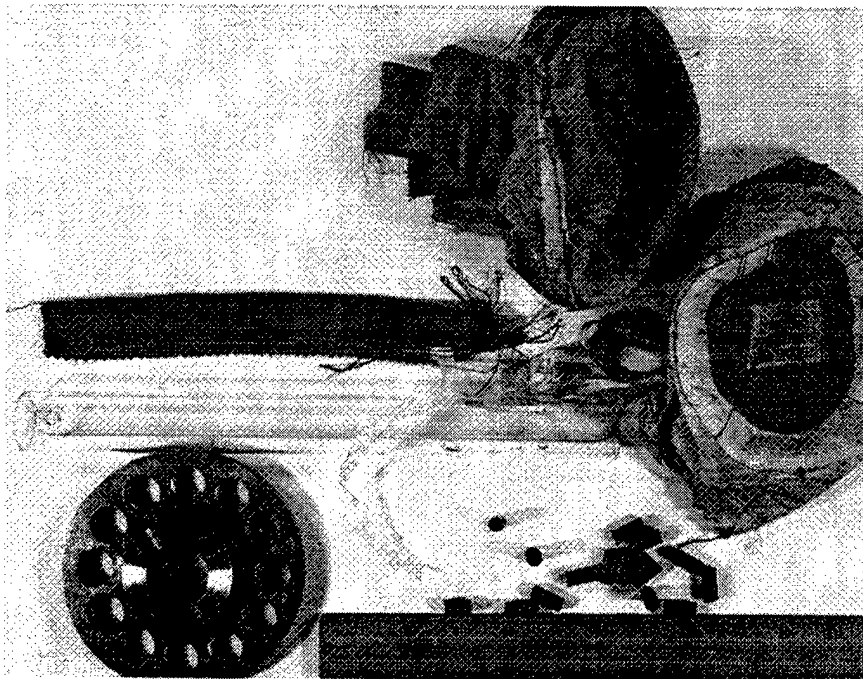
**Figure 4. Fully Assembled Igniter Simulator Charge Views:
(a) Normal and (b) Disassembled.**

An exploded view of a typical charge can be seen in Figure 4(b), with a few representative grains of inert propellant. In this case, both the snake and the base pad are empty. An assembled view of this charge can be seen in Figure 4(a). It should be mentioned here that, for Runs 1-23, the center of the charge was carefully aligned with the primer output spit hole. Later runs were directed at testing the concept that misalignment of the charge could contribute to the hangfires.

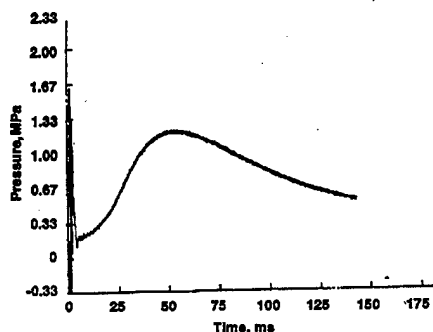
Figure 5. Pressure vs. Time for Run 4, Gauge 3. The 203 Base Pad With 28 g (1 oz) of Black Powder and a Conditioning Temperature of -54°C .

3.1.2 Run 4. Ignition delays and pressures are listed in Table 1. The M82 primer pulse was a distinct event and can be separated from the operation of the base pad. Note that Gauge 3, located directly in line with the primer, sees a much larger pressure than Gauge 1 or 2. Figure 5 is a pressure-time curve for Gauge 3. The pressure pulse from the M82 is clearly seen at about 3 ms. The Diode 1 signal is shown in Figure 6. The M82 light output is observed at around 3 ms, followed by the base pad light output, which saturates the system. The pressures measured in these

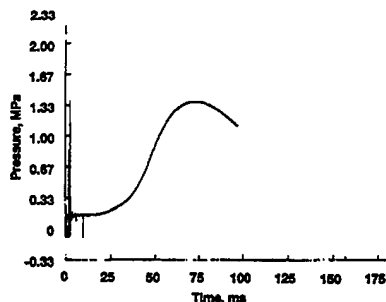
Figure 17. Pressure vs. Time for Run 15, Gauge 3. The 203 Base Pad (Empty) and Snake, 50 g of Black Powder and a Conditioning Temperature of -54°C .

3.7.1 Run 15. This experiment was run as pictured in Figure 4(a) except that the base pad was emptied of black powder. The end of the snake was 8 cm from the base pad. Pressure-time trace is shown in Figure 17. It is seen that the delay is considerably longer than for the base pad alone, although far from hangfire conditions.
